Furniture Row Shopping Center

Problem: A furniture store needs a fire sprinkler system but there is no municipal water service available.

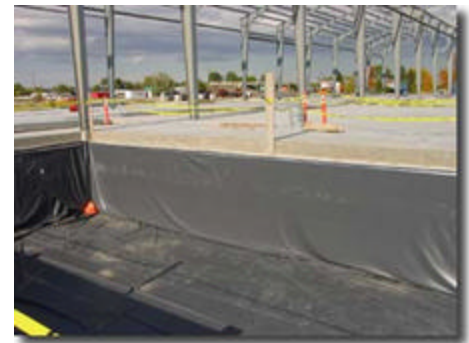
Solution: Build a reservoir under the building lined with 60 mil PVC from EPI. That was the answer for the Furniture Row Shopping Center store in Billings, Montana. A 26' x 48' x 8' deep poured concrete tank was constructed in one corner of the building. EPI provided a one piece, 45' x 68' sixty mil PVC liner panel for the interior of the tank. The liner was unfolded in place and was anchored around the top perimeter with aluminum batten. Total time to install the liner and batten: 6 hours!

77,000 gallons of water for fire protection at the store.

Then the tank was covered with pre-cast concrete planks to form the floor of the warehouse and showroom. The 10,350 cubic foot tank stores over
